Our MGB

In 2006, a daughter and son-in-law (Anitra and Todd VanProoyen) bought us a 1976 MGB. They both knew that I had always liked MGBs and they had the opportunity to buy one for \$600 that needed some work. Perhaps that's an understatement. The body had damage, the interior was shot, it didn't run and, to put it kindly the DPO (technical automotive term: Dumb Previous Owner) had gotten very creative with the wiring on the car. This little article is a recap of 10 years work bringing the car back to life illustrated in pictures. I wish we had more pictures, but I never set out with the idea of documenting all that we did and was very surprised that I was able to sift through our pictures over the years and find the ones I did.

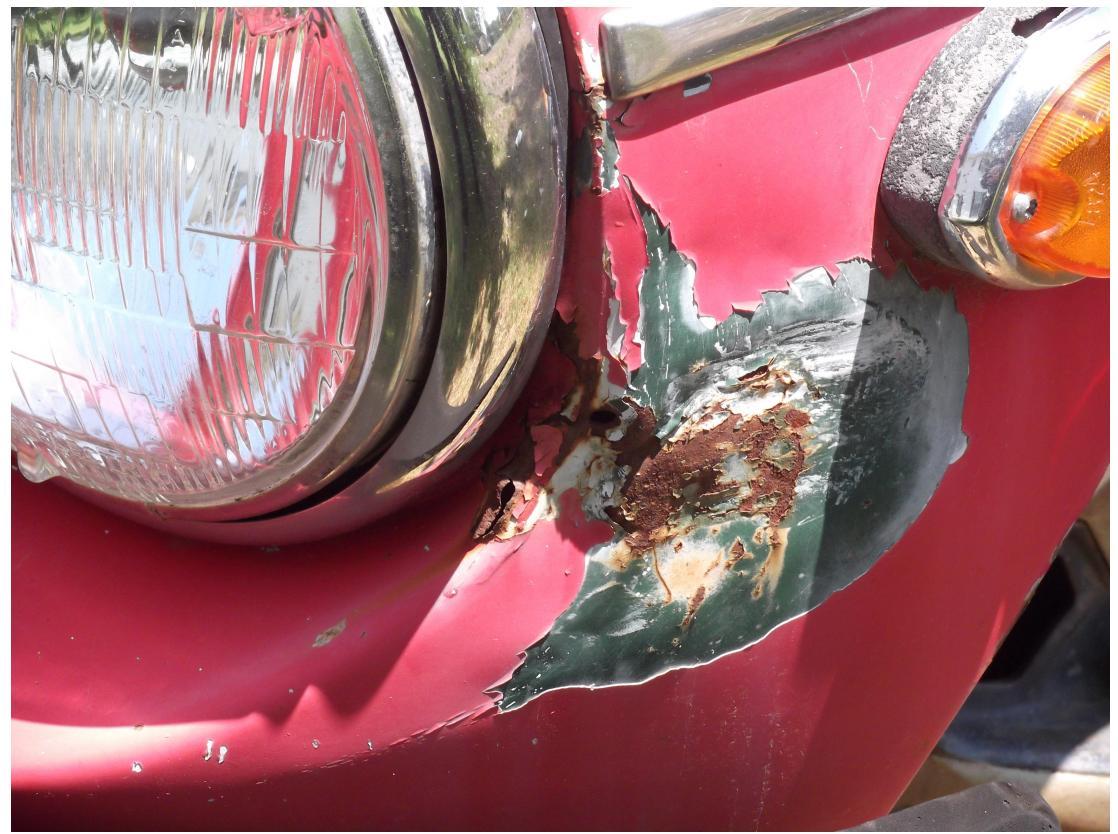
The body had two types of damage: rust and dings from accidents

(Note the side marker light's brittle and failed gasket - this was typical) The driver's side fender

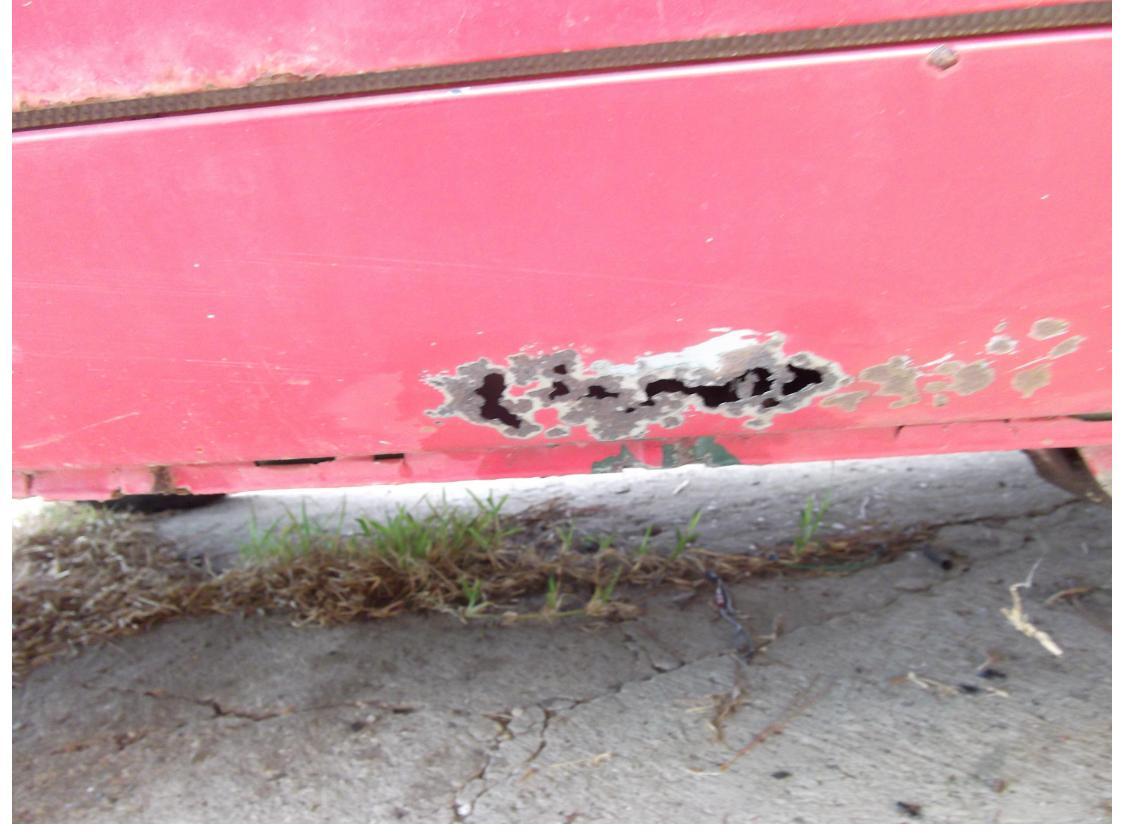
and this rail are examples.

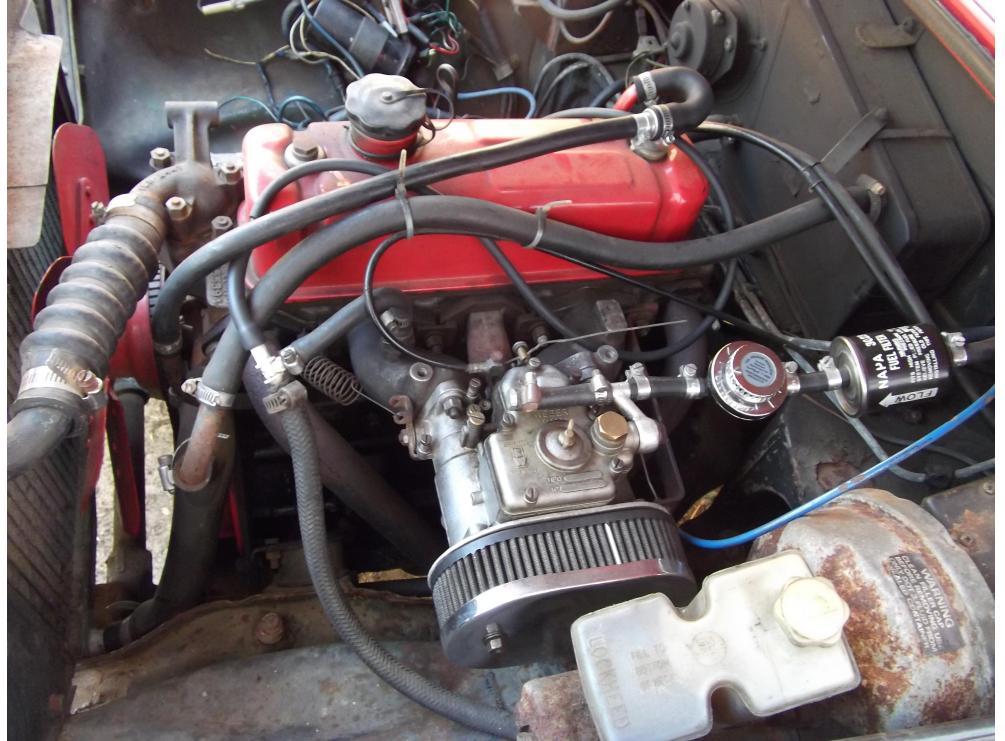
It had a Holly side draft that the regulator and filter I added couldn't help

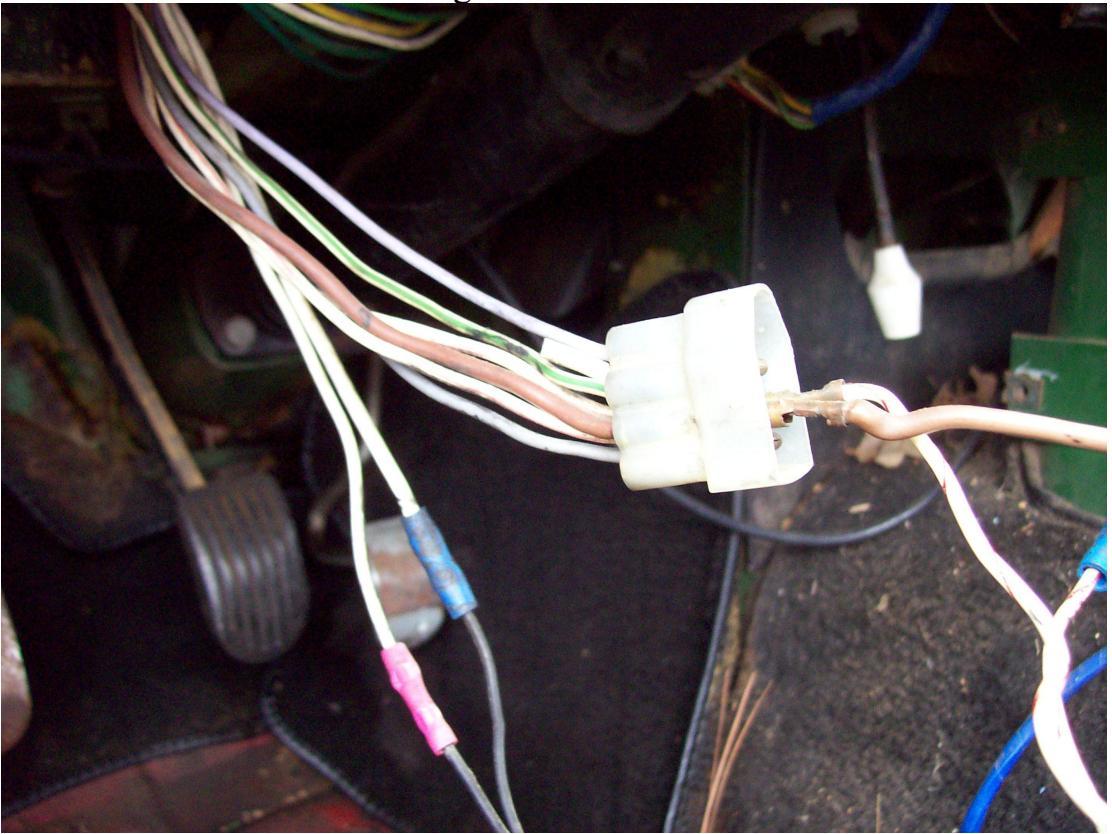
The wiring was over 90% non-functioning - Two wires ran from the ignition switch

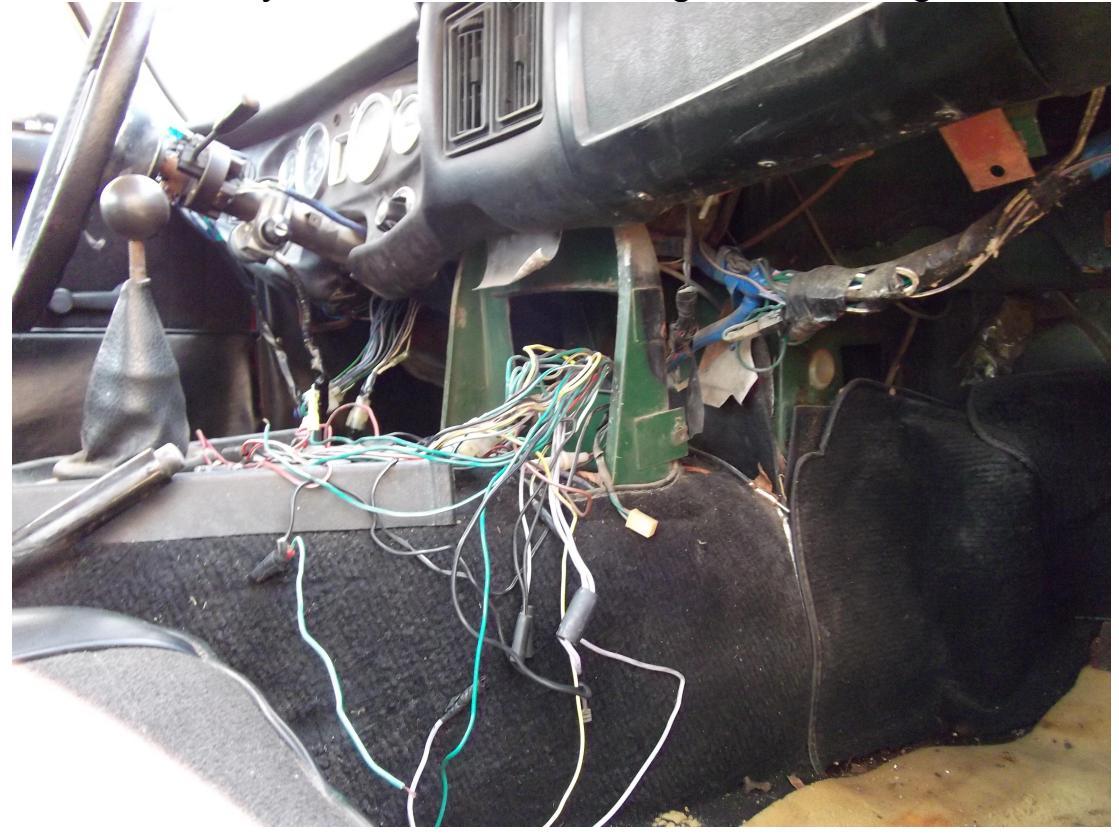
Many wires were cut, twisted together or missing

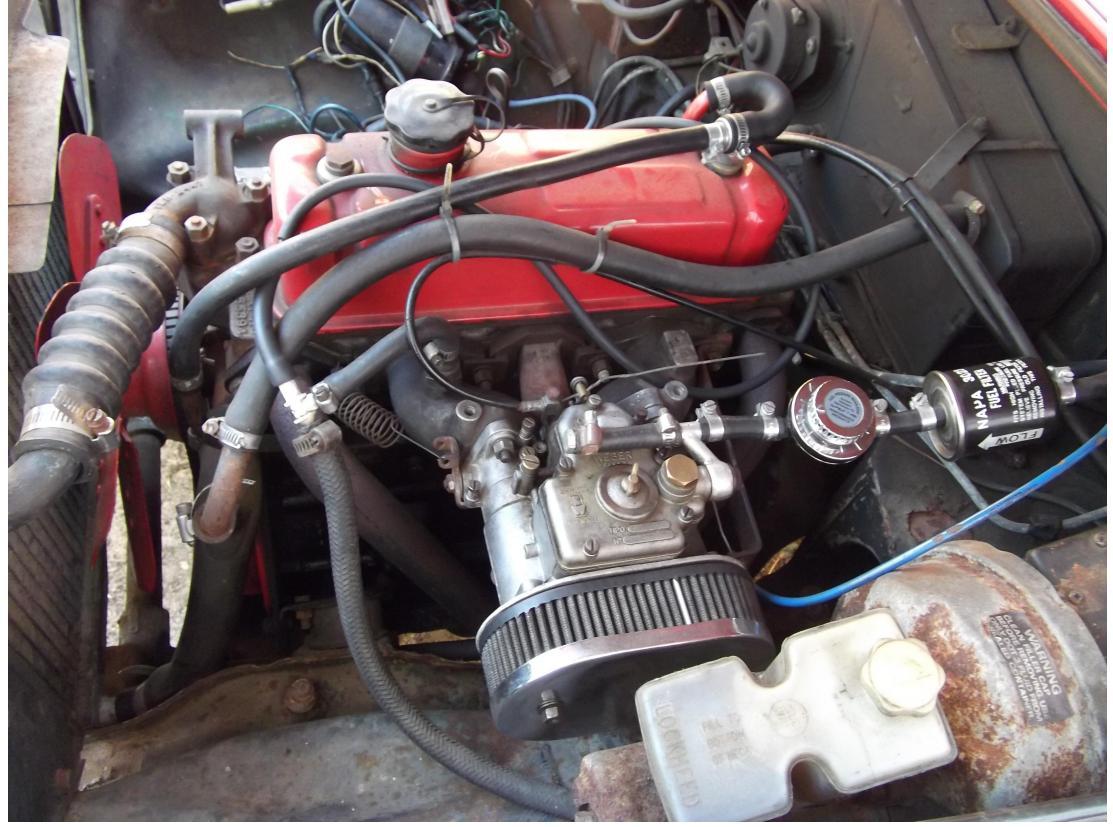
We first focused on the carburetor. Having incorrect fuel pressure can prevent the carburetor from working and there was also the possibility that there was junk in the tank affecting the carburetor. We put new fuel in, added a fuel filter and a pressure regulator to no avail.

I checked that we were getting proper spark, had compression and that yes, the fuel pressure from the pump was correct. It would crank, try to start and badly shake for a second or two, but never run. I checked the spark plug wires to see what firing order they were set up for. I gave up for a couple of months.

Then it hit me. MGB's distributors (unlike MOST American distributors) run in a counter clockwise direction. Had I checked to see which way the firing order was set up? I didn't remember. But when I checked, I found that the firing order was correct for clockwise rotation and NOT for counterclockwise rotation. Could it be that simple?

I set up the firing order as it should have been and to my surprise, the car started running!

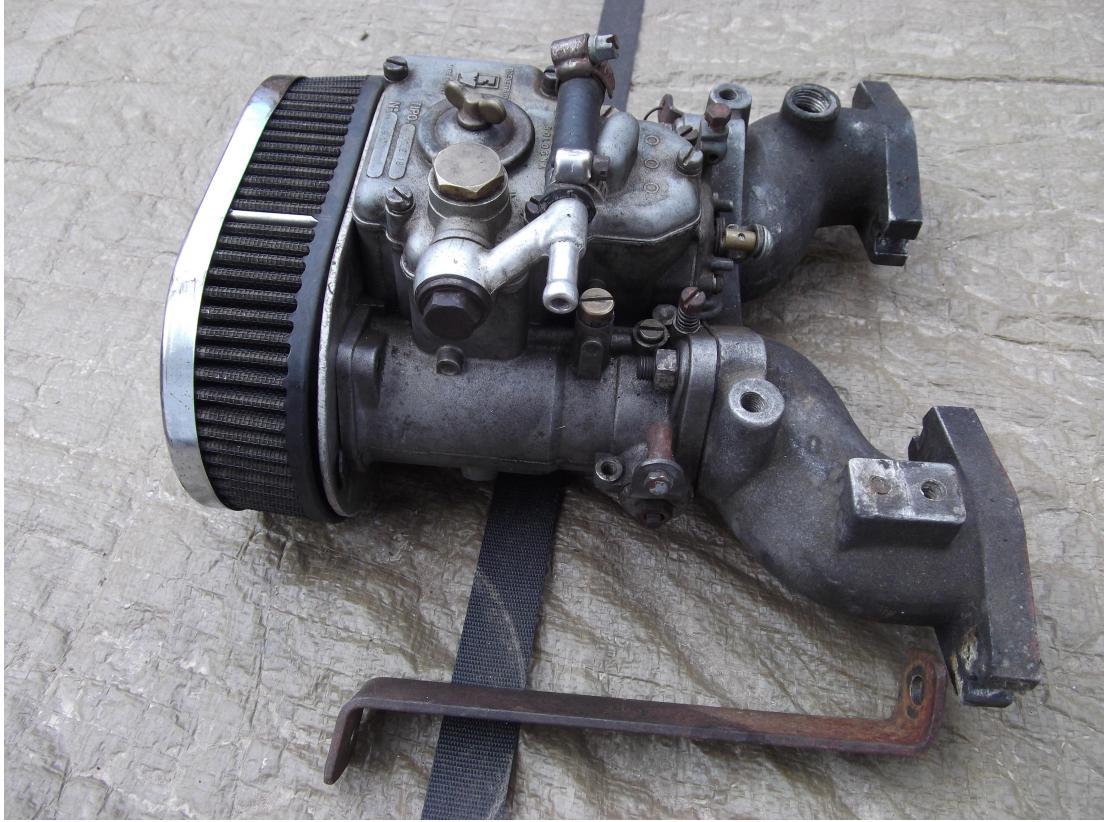
It still wouldn't run well and Pam had the Holly rebuilt for my birthday

That helped, but we realized it needed replacing - it was too worn out My Christmas present was a Weber downdraft carburetor I took this picture to help identify proper plumbing of the carburetor:

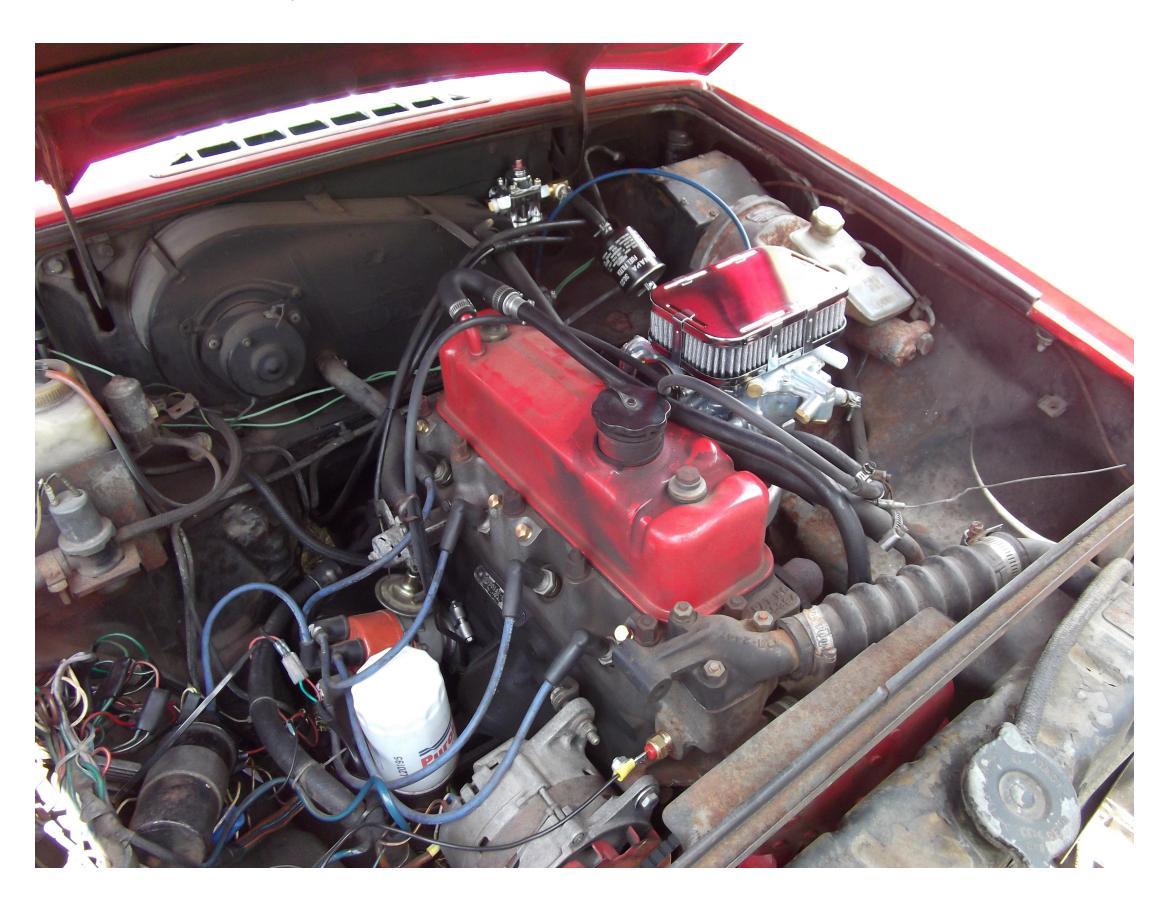
Before going on to attempt to address some of the problems with the electrical system, it was time to take care of two other problems. The distributor was not in good shape and the DPO had removed the air pump and rail without capping the holes.

You may notice the wire leading from the engine temperature sensor just above the alternator. What was there when Todd bought the car was a bolt about 8" long protruding from the hole. The DPO had removed the sensor. I don't know if he just didn't care at what temperature the car was running or if he just didn't feel like tracking down a supplier for the part, but that was just one of the items not being tracked by any gauge in the dash. The oil pressure gauge (it's non-electrical) was the only gauge that worked.

Another birthday, father's day or Christmas (It's long enough ago that I don't remember) Pam bought a Petronix distributor. I added that on a started trying to take care of some of the other problems. Here is a picture of the new distributor and brass bolts with which we plugged the holes (I think they were 1/4 28s).

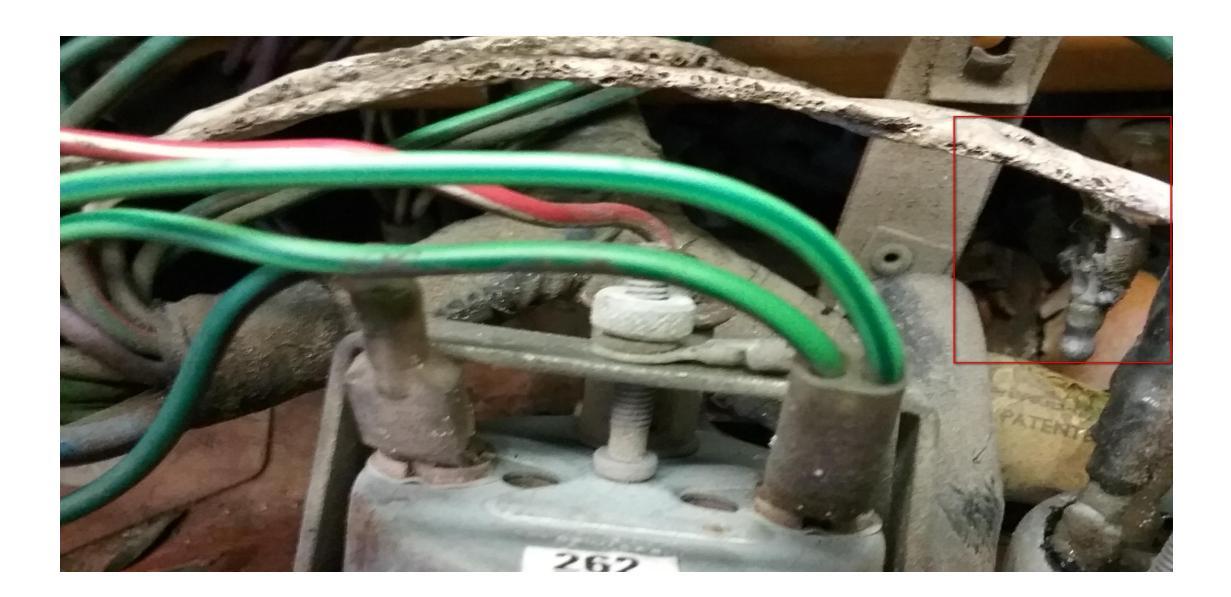
The connector without any black tape is the original connector I ordered the other half of it and both halves of the one nearest the camera I don't want to bore anyone so I will only show you a couple more pictures of some of the condition of the wiring and how we were able to reconstruct the electrical systems and leave the rest of that task to your imagination. The box shows a connector dangling from a burned wire.

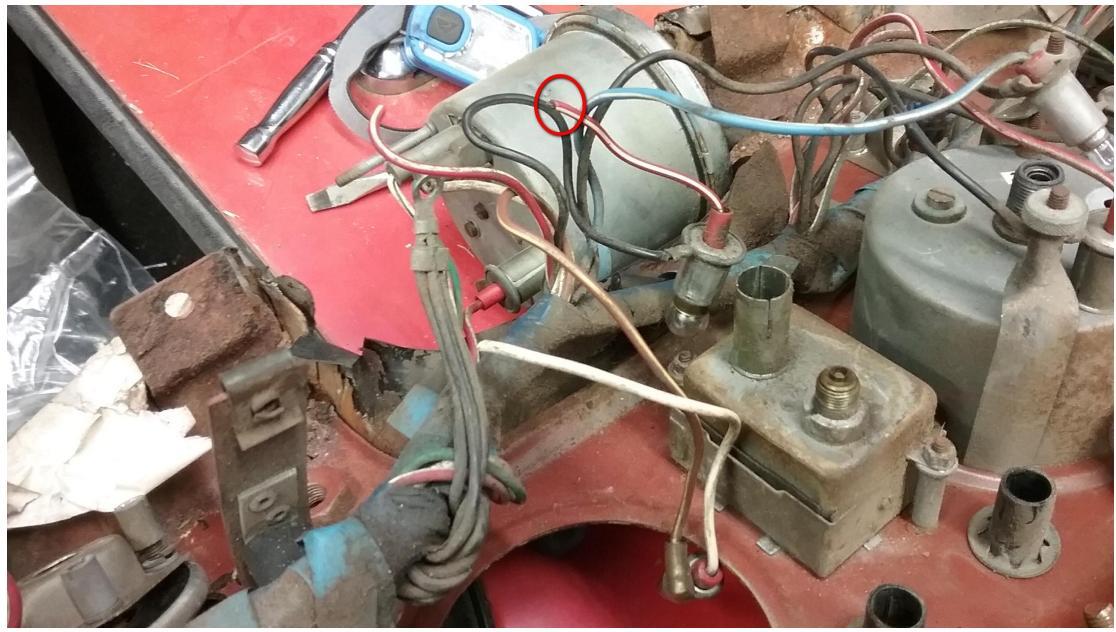
There were wires cut for no discernible reason - some patched back on

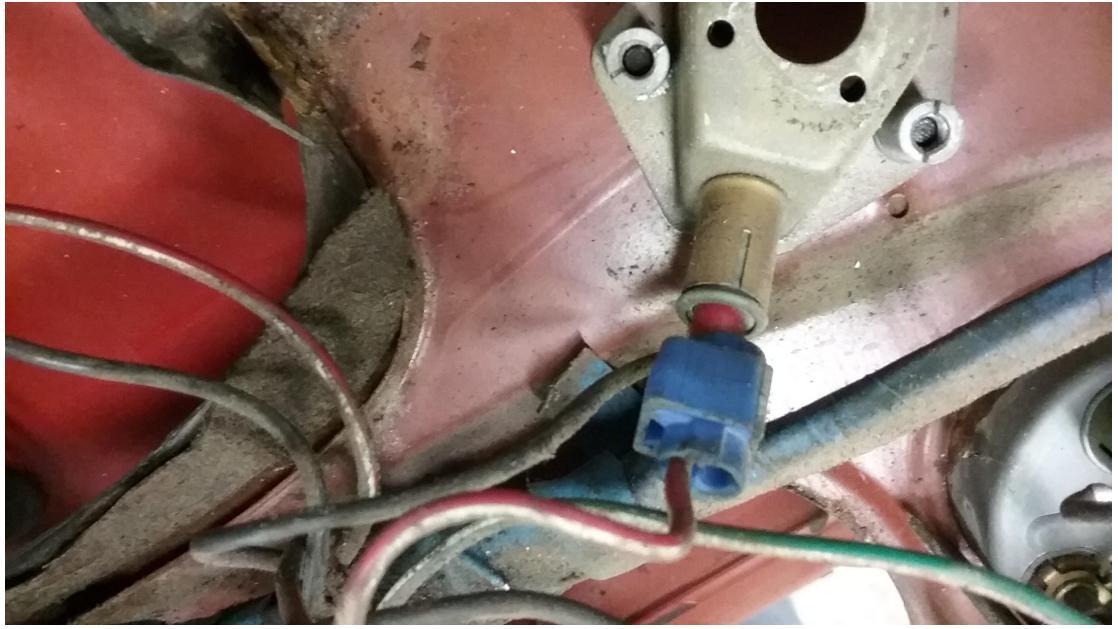
Note the red circled wire

This one was cut and then re-attached
