Our MGB

In 2006, a daughter and son-in-law (Anitra and Todd VanProoyen) bought us a 1976 MGB. They both knew that I had always liked MGBs and they had the opportunity to buy one for \$600 that needed some work. Perhaps that's an understatement. The body had damage, the interior was shot, it didn't run and, to put it kindly the DPO (technical automotive term: Dumb Previous Owner) had gotten very creative with the wiring on the car. This little article is a recap of 10 years work bringing the car back to life illustrated in pictures. I wish we had more pictures, but I never set out with the idea of documenting all that we did and was very surprised that I was able to sift through our pictures over the years and find the ones I did.

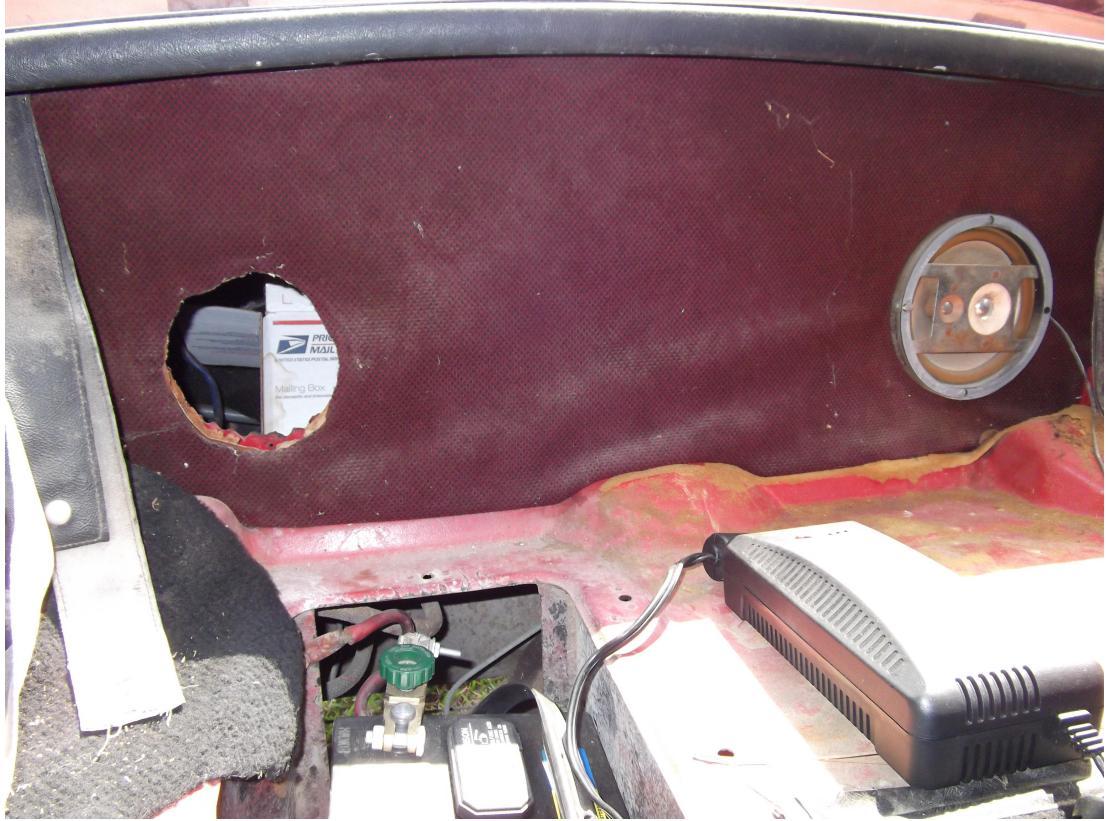
INTERIOR Here are a couple of pictures of the interior:

The DPO cut holes and created this unique bulkhead panel

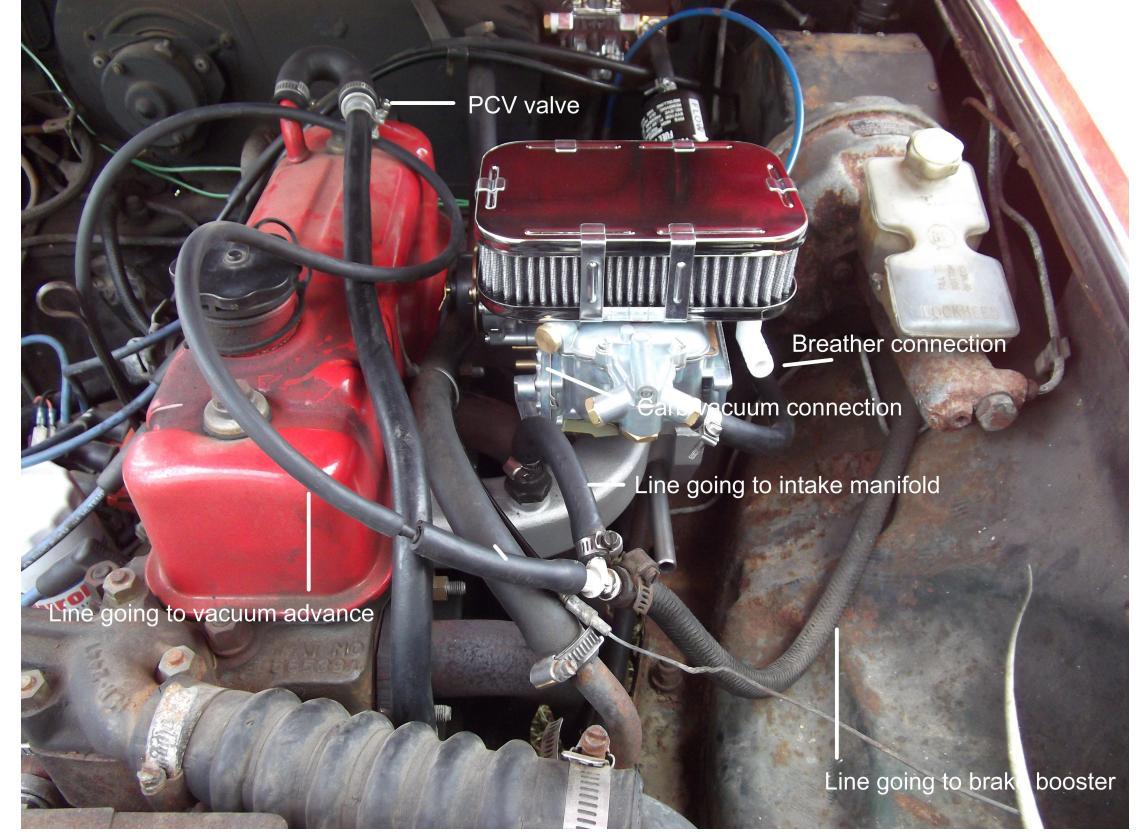
That helped, but we realized it needed replacing - it was too worn out My Christmas present was a Weber downdraft carburetor I took this picture to help identify proper plumbing of the carburetor:

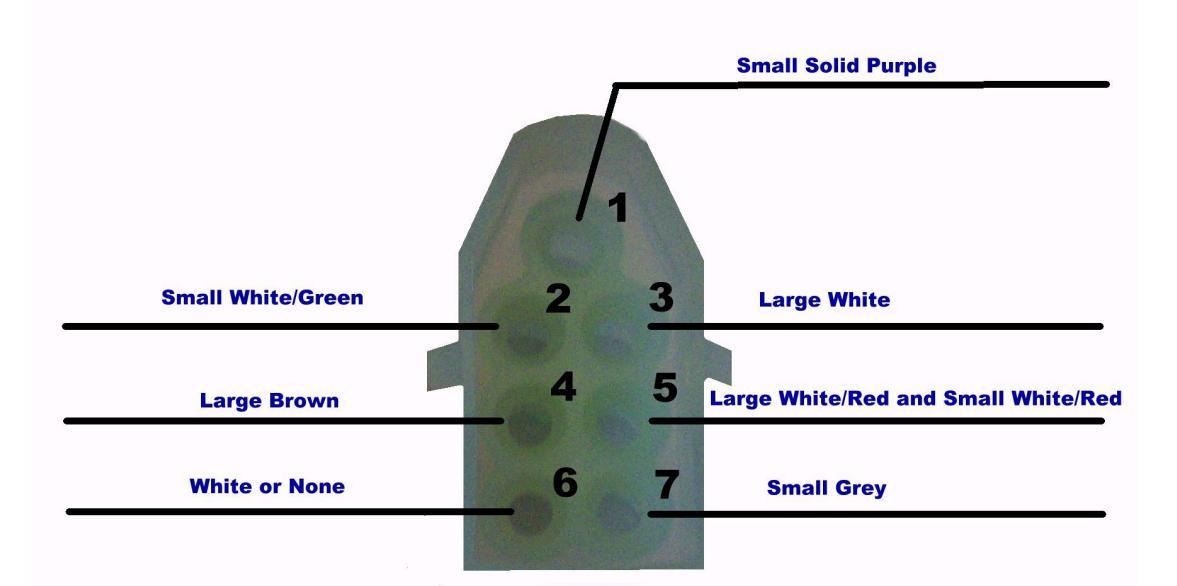
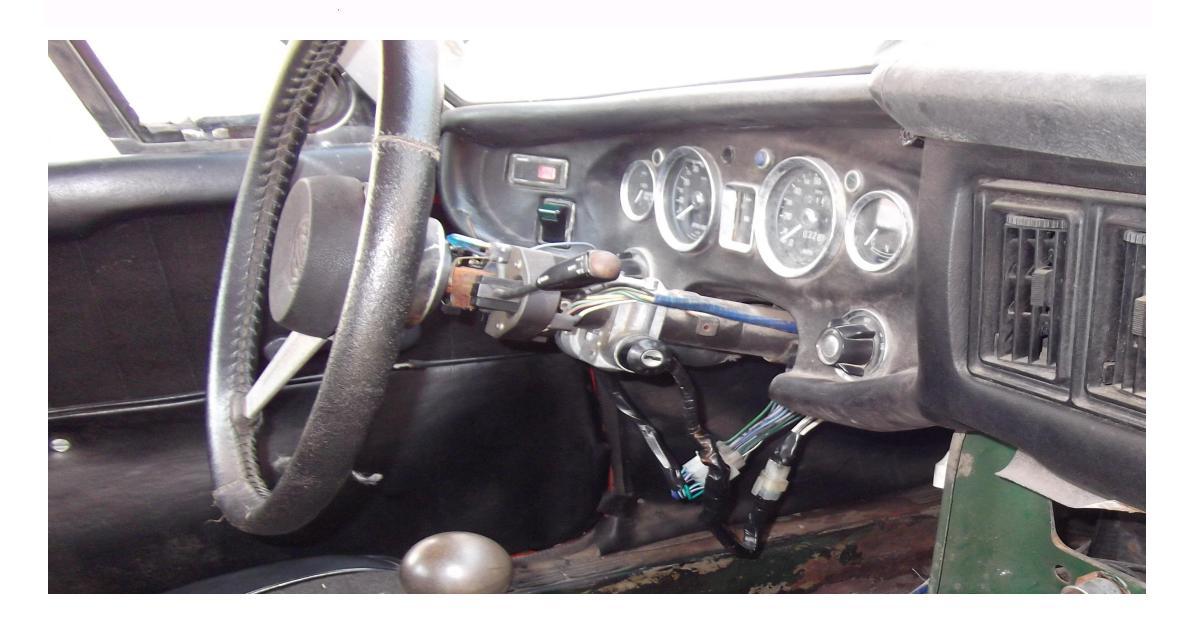
The electrical system was a major undertaking. Why didn't the turn signals, the lights, the gauges, etc. work? I knew that a major reason was that there was only one connector intact from the ignition switch to the wiring harness. There should have been two female connectors and two male. There was only one male. I found a source in Great Britain that sold the correct connectors. I took pictures of the connectors from the website, researched what should have been there and built the ignition switch connectors. Here is one extant picture of a diagram of one of the connectors I created:

The connector without any black tape is the original connector I ordered the other half of it and both halves of the one nearest the camera I don't want to bore anyone so I will only show you a couple more pictures of some of the condition of the wiring and how we were able to reconstruct the electrical systems and leave the rest of that task to your imagination. The box shows a connector dangling from a burned wire.

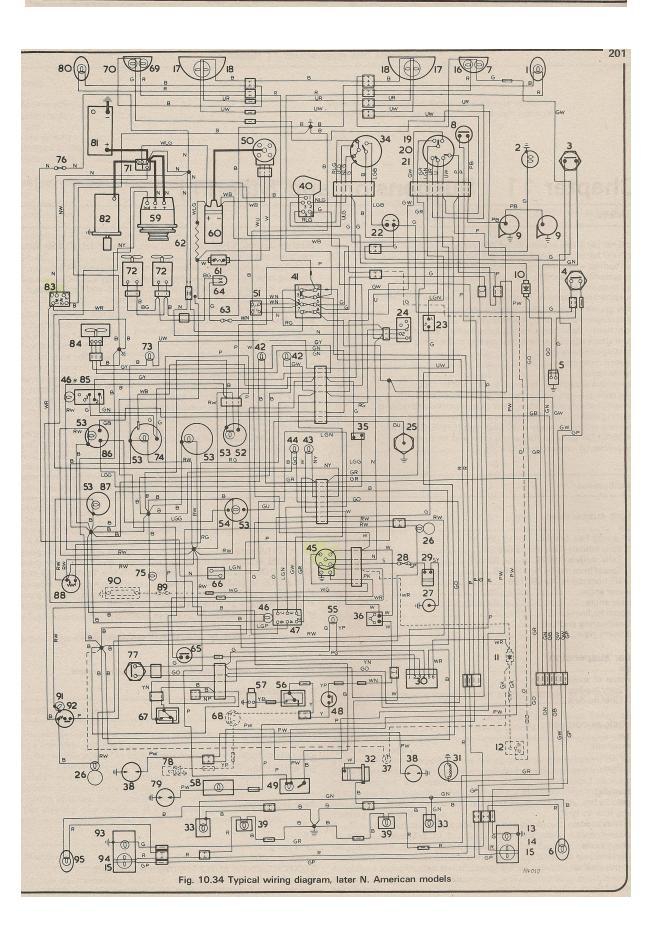
There were sometimes two wires leading to a single post and none of them connected to anything. It would take many months to go through all of the wiring and determine why the fuel gauge didn't work or the tail lights or the flashers and on and on. I obtained a full set of schematics for the car, highlighted the component I need to bring back to life and traced all wires leading to or from it.

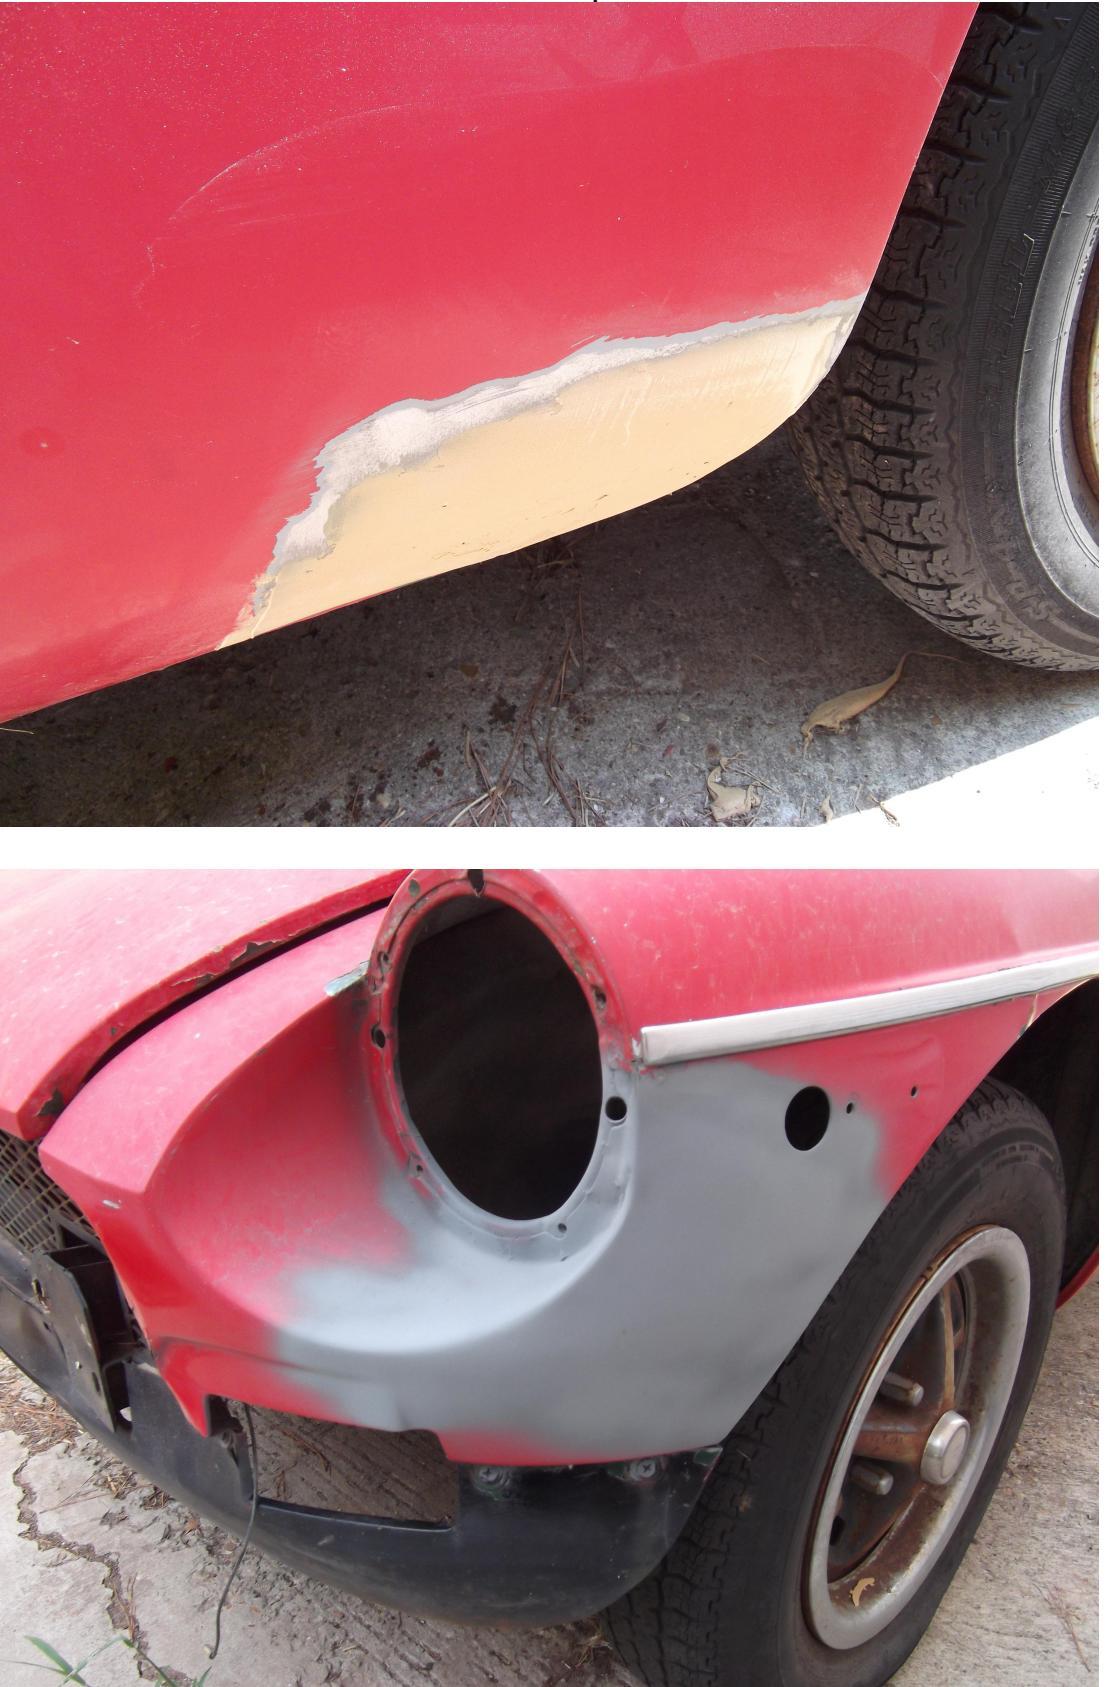
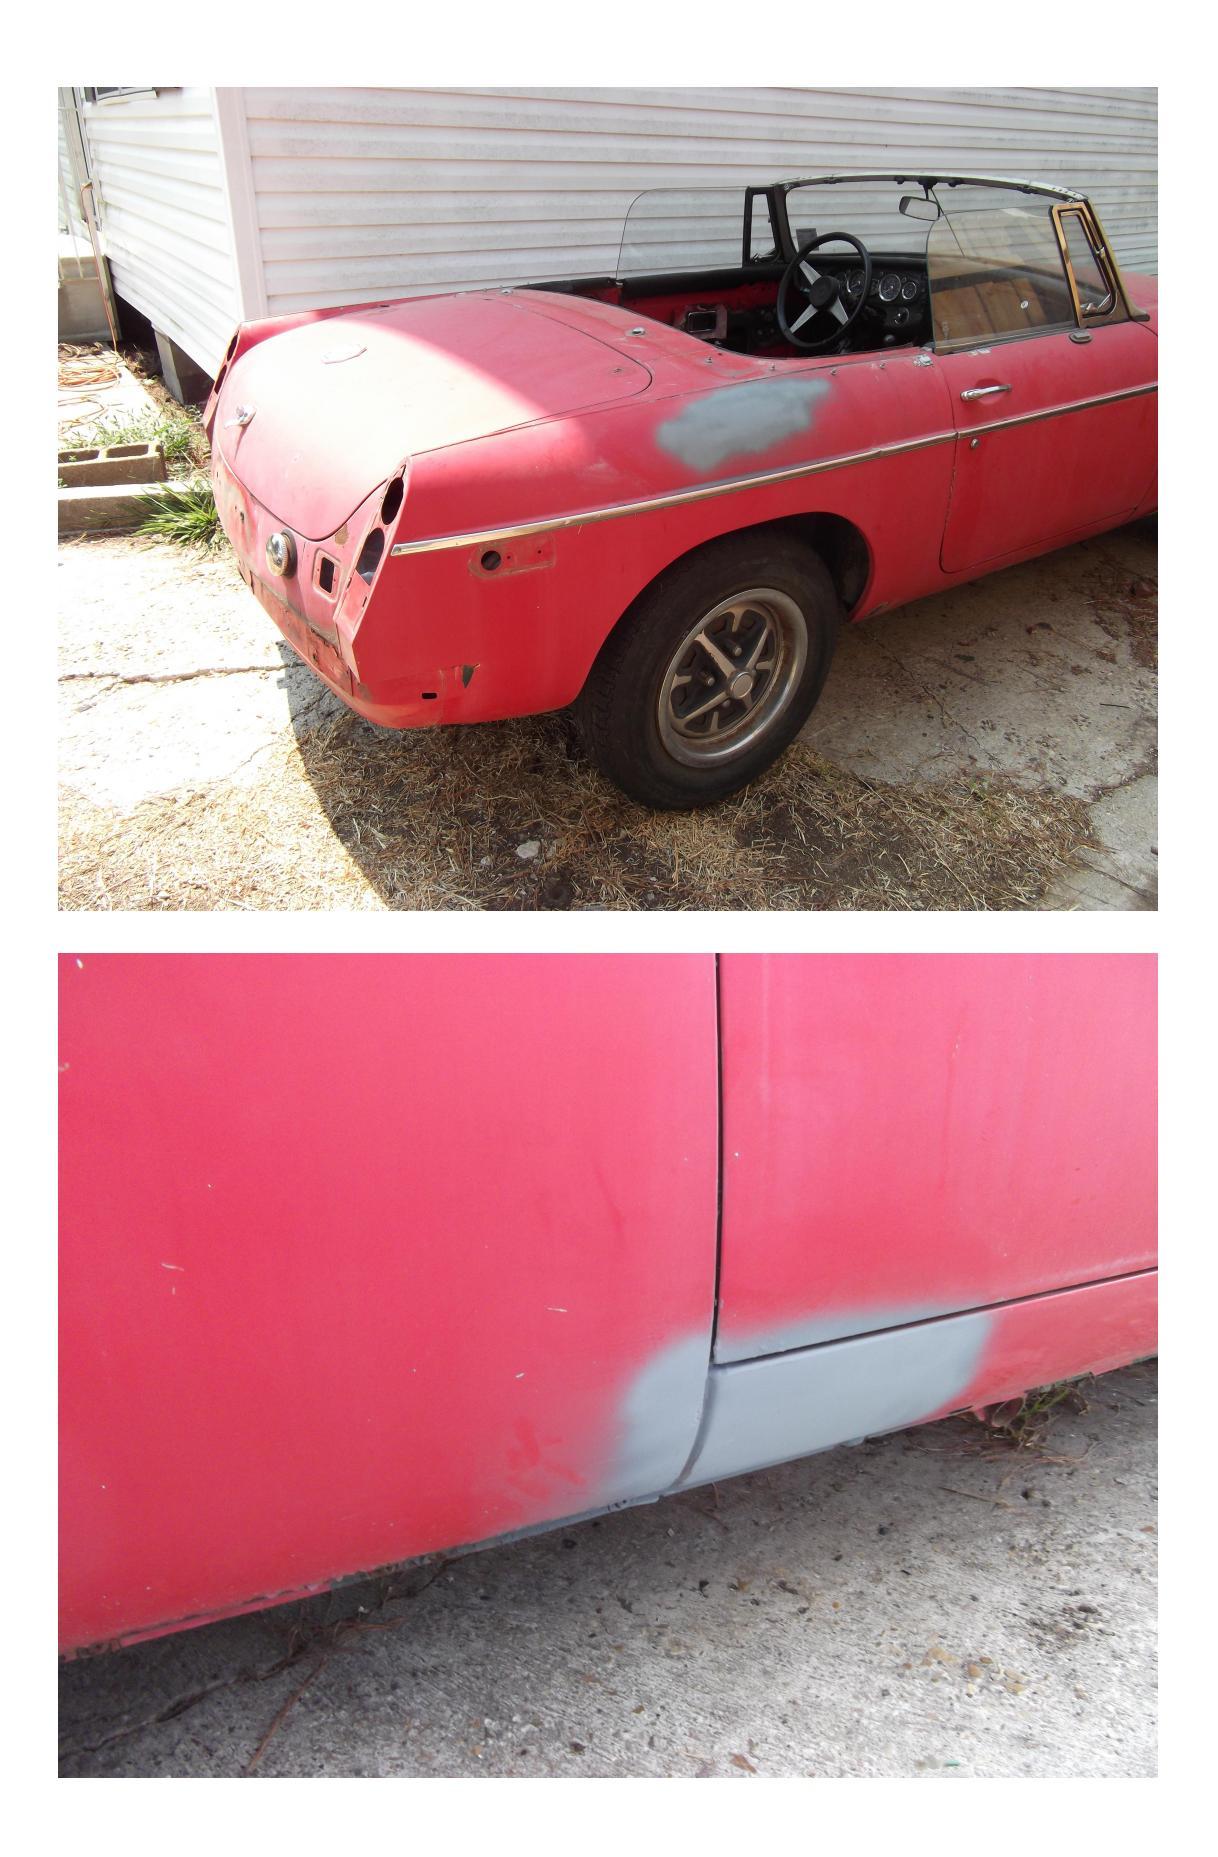
It was time to tackle the body These are a few of the pictures we took:

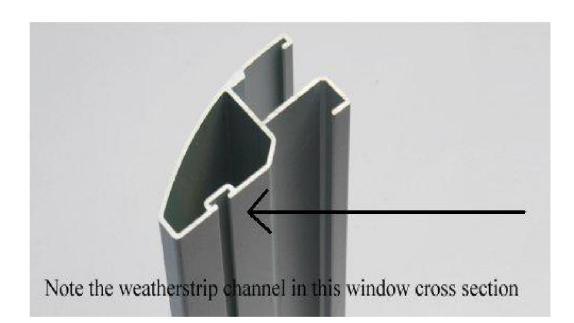
It has often been posted that the factory must have had some way to easily install the bottom windshield gasket. This is true. If you look at the cutaway of a regular house window sash, you will see the identical groove into which the bottom MGB windshield gasket must be installed. Having worked as a glazier for 15 years in two of my father-in-law's factories and in the field, I am very familiar with this type of installation. It is the same groove used for weatherstripping on windows.

The truth of the matter is that this grove does not have anything to do with sealing a window or a windshield to the body of a car. It is there only to hold the gasket or weatherstripping <u>in place</u>. The gasket, itself, is what seals the windshield to the car body. Whoever is currently producing the seal did not understand this and has over-engineered this part of the windshield gasket. This part of the gasket should be thin enough to easily slide into the groove in the bottom of the windshield frame. In the factory, I can guarantee that they simply pulled the seal into place with no effort at all as it simply slid down the track. (And was quite likely pre-cut to length!)

So what to do about the problem? In the window business, I was often sent out to repair windows that had been damaged by builders in the course of their installation. One of the things that was occasionally damaged was the weather stripping. However, once the window was installed, you could NOT disassemble it to gain access to the end of the weatherstripping. In effect, you had the same problem that exists with an MGB windshield gasket if you do not want to disassemble the windshield and which also exists even if you do, because the poor engineering of the gasket does not allow you to easily pull it in place.

The solution in the field (which works for the MGB windshield) is to hold the interior edge of this part of the gasket in the installation track (similar to the track of the window pictured above) and to use a leather worker's bent-tipped awl or (similar tool) to work the other edge of this part of the gasket into the track. Work from the center to each end of the windshield.
